Construction Update #1

August 6, 2021

Demolition

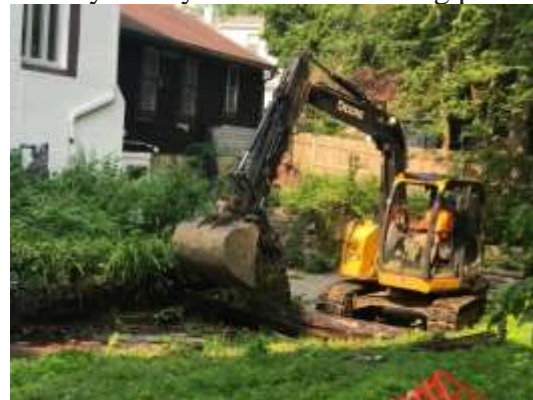
In the back yard, the hazardous materials abatement crew removed asbestos shingles from the north side of the building during the week of July 12. Soon after abatement was completed, a work crew began demolishing the earth berms along the north wall of the building. This work will make way for the addition that will house our new classrooms, hospitality spaces and elevator.

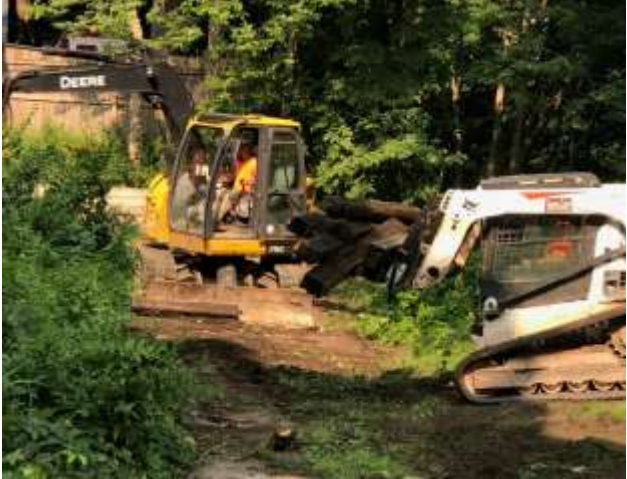
As the rotting railroad ties and old concrete patio were torn up a small fork lift carried the refuse up to the parking lot.

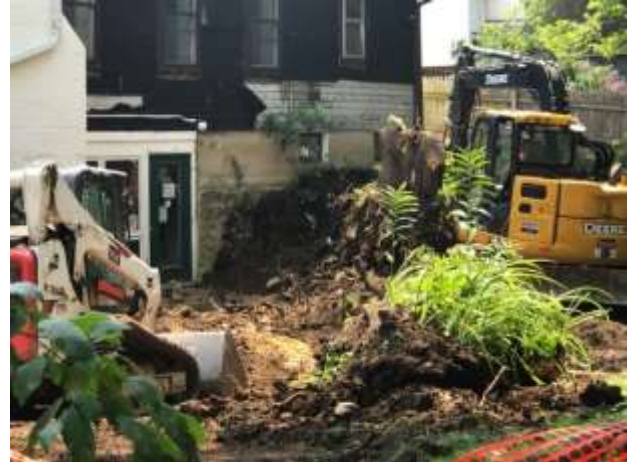
Removing the deeply rooted walnut tree stumps has been one of the biggest challenges.

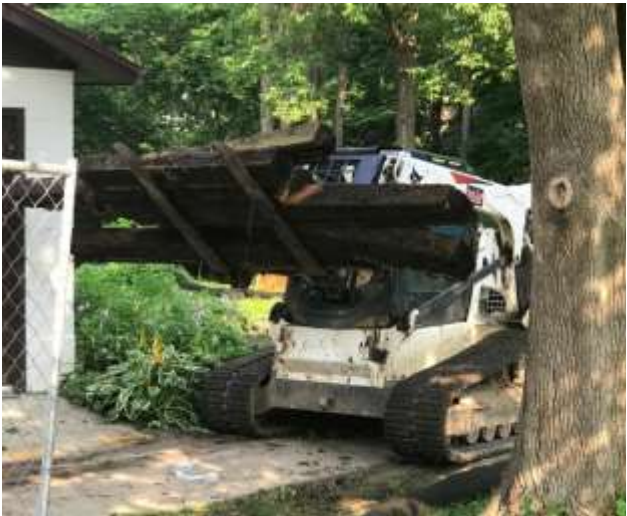
By using small equipment like this fork lift and running it on the sidewalk, Ideal has taken significant steps to protect the maple tree on the northeast corner of the building. Most important, instead of running a large, heavy cement truck into the back yard, they plan to pump cement over the roof of the Meetinghouse.

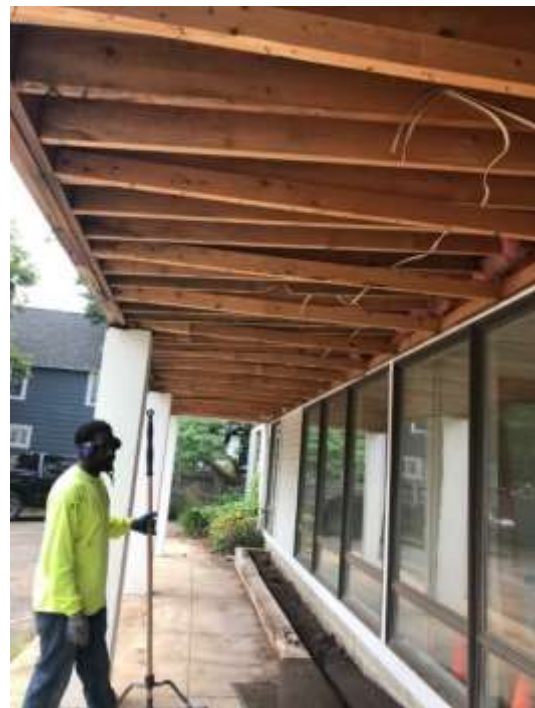
The old portico ceiling was removed due to water damage and discoloration from roof leaks. Fortunately, most of the superstructure was found to be sound. Only a few outer timbers near the post showed signs of water damage and will have to be replaced.

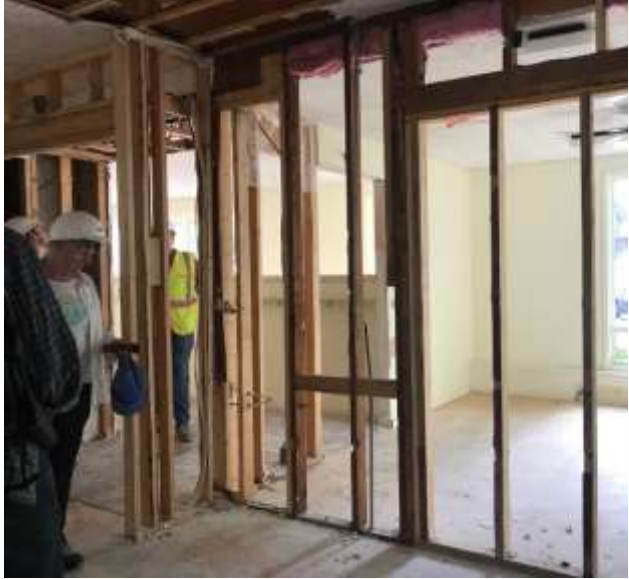
The wall between the coat racks and the sunroom is being removed to create the new lobby.

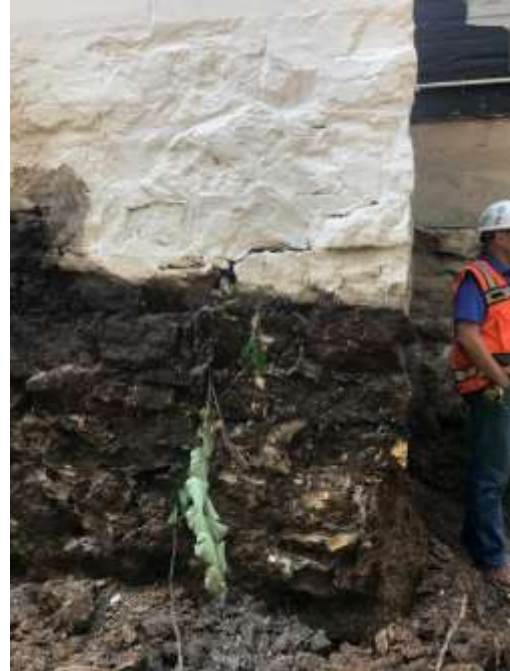
Excavation along the furnace room wall revealed that the wall did not reach the basement floor level or have a footing. This area will need to be underpinned with concrete to provide adequate support for the existing wall and to create an adequate base for the new addition.

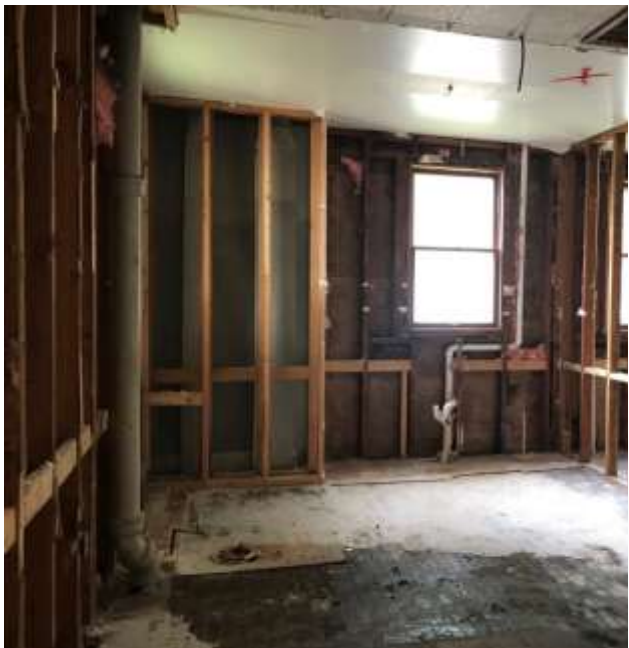
A view of the main level bathroom (left) and corner of the office (right) after initial demolition.

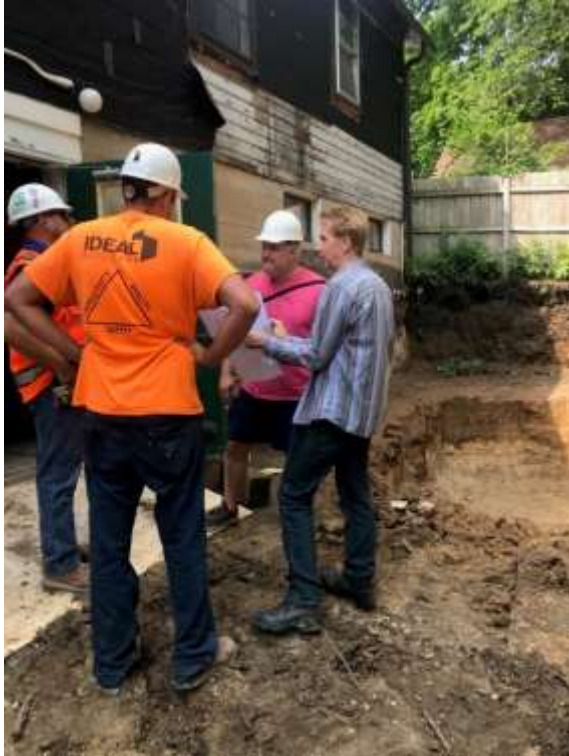
The morning after Ideal discovered that the sandstone wall needed structural underpinning, Architect David Ferch and his structural engineer met with Ideal's site superintendent and safety manager to discuss the issues and details for underpinning the foundation wall. David has already completed the necessary plans. The work is complicated and will require considerable care.
