Construction Update #1

August 6, 2021

Demolition

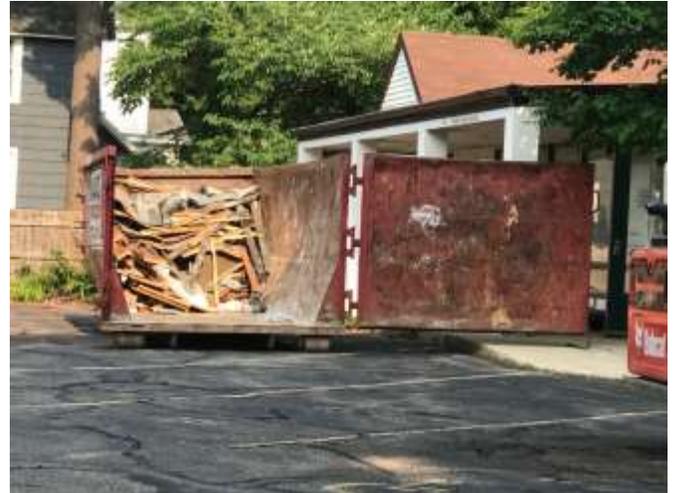
Our contractor, Ideal Builders, delivered an industrial size dumpster to facilitate proper handling of demolition waste.

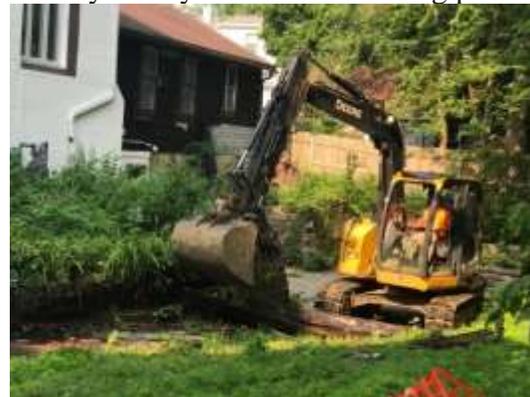
In the back yard, the hazardous materials abatement crew removed asbestos shingles from the north side of the building during the week of July 12. Soon after abatement was completed, a work crew began demolishing the earth berms along the north wall of the building. This work will make way for the addition that will house our new classrooms, hospitality spaces and elevator.

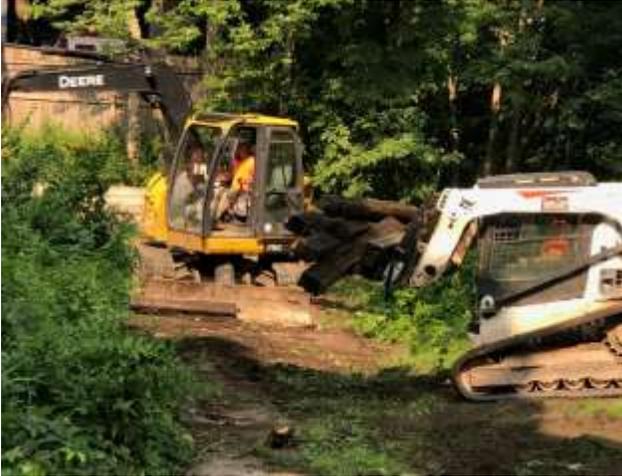
As the rotting railroad ties and old concrete patio were torn up a small fork lift carried the refuse up to the parking lot.

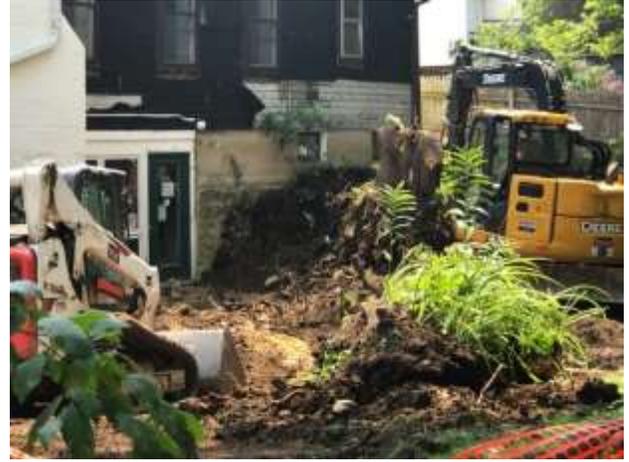
Removing the deeply rooted walnut tree stumps has been one of the biggest challenges.

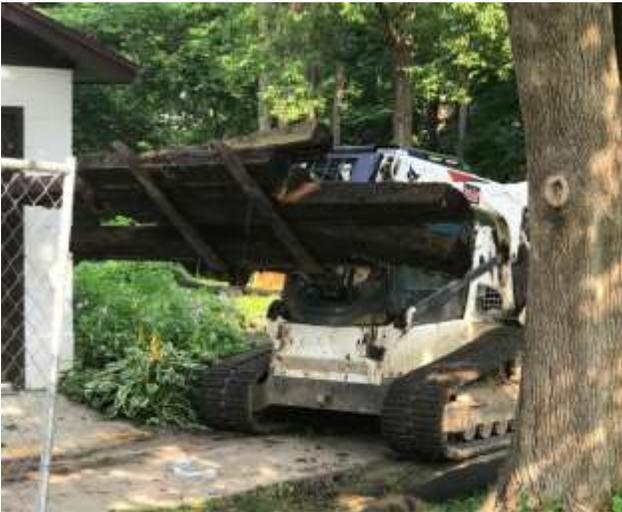
By using small equipment like this fork lift and running it on the sidewalk, Ideal has taken significant steps to protect the maple tree on the northeast corner of the building. Most important, instead of running a large, heavy cement truck into the back yard, they plan to pump cement over the roof of the Meetinghouse.

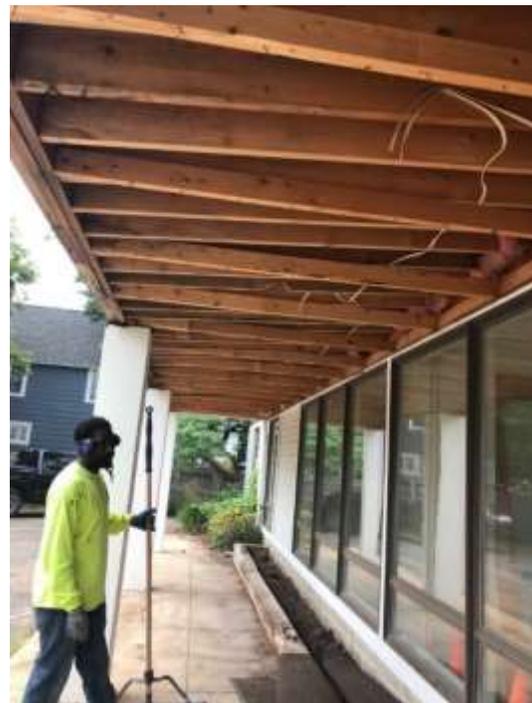
The old portico ceiling was removed due to water damage and discoloration from roof leaks. Fortunately, most of the superstructure was found to be sound. Only a few outer timbers near the post showed signs of water damage and will have to be replaced.

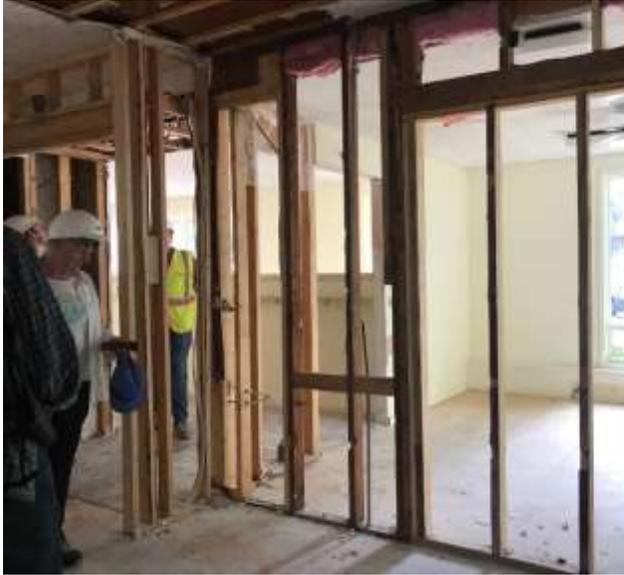
The wall between the coat racks and the sunroom is being removed to create the new lobby.

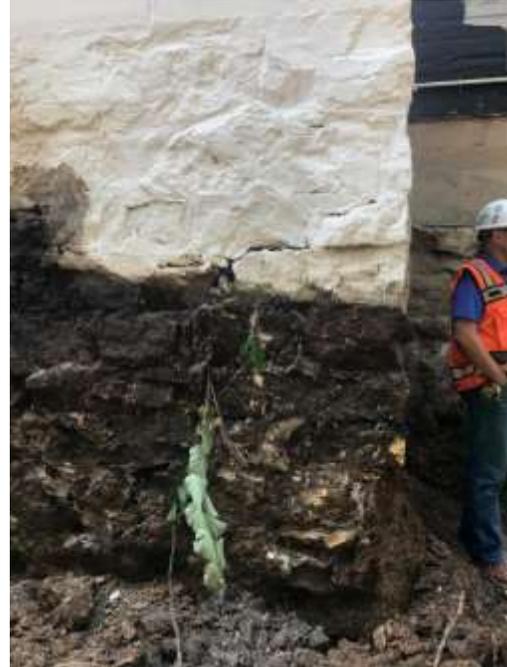
Excavation along the furnace room wall revealed that the wall did not reach the basement floor level or have a footing. This area will need to be underpinned with concrete to provide adequate support for the existing wall and to create an adequate base for the new addition.

The morning after Ideal discovered that the sandstone wall needed structural underpinning, Architect David Ferch and his structural engineer met with Ideal's site superintendent and safety manager to discuss the issues and details for underpinning the foundation wall. David has already completed the necessary plans. The work is complicated and will require considerable care.

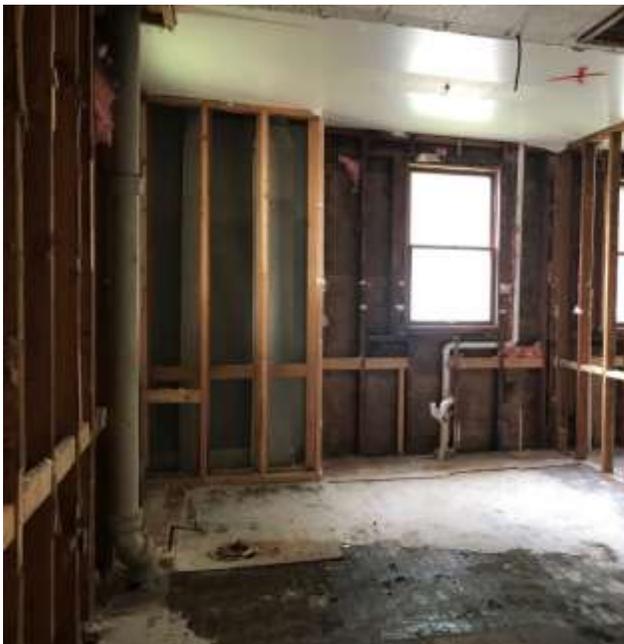
A view of the main level bathroom (left) and corner of the office (right) after initial demolition.
